Failure Case Studies in Civil Engineering

Structures, Foundations,
and the Geoenvironment

SECOND EDITION

Technical Council on Forensic Engineering
of the American Society of Civil Engineers

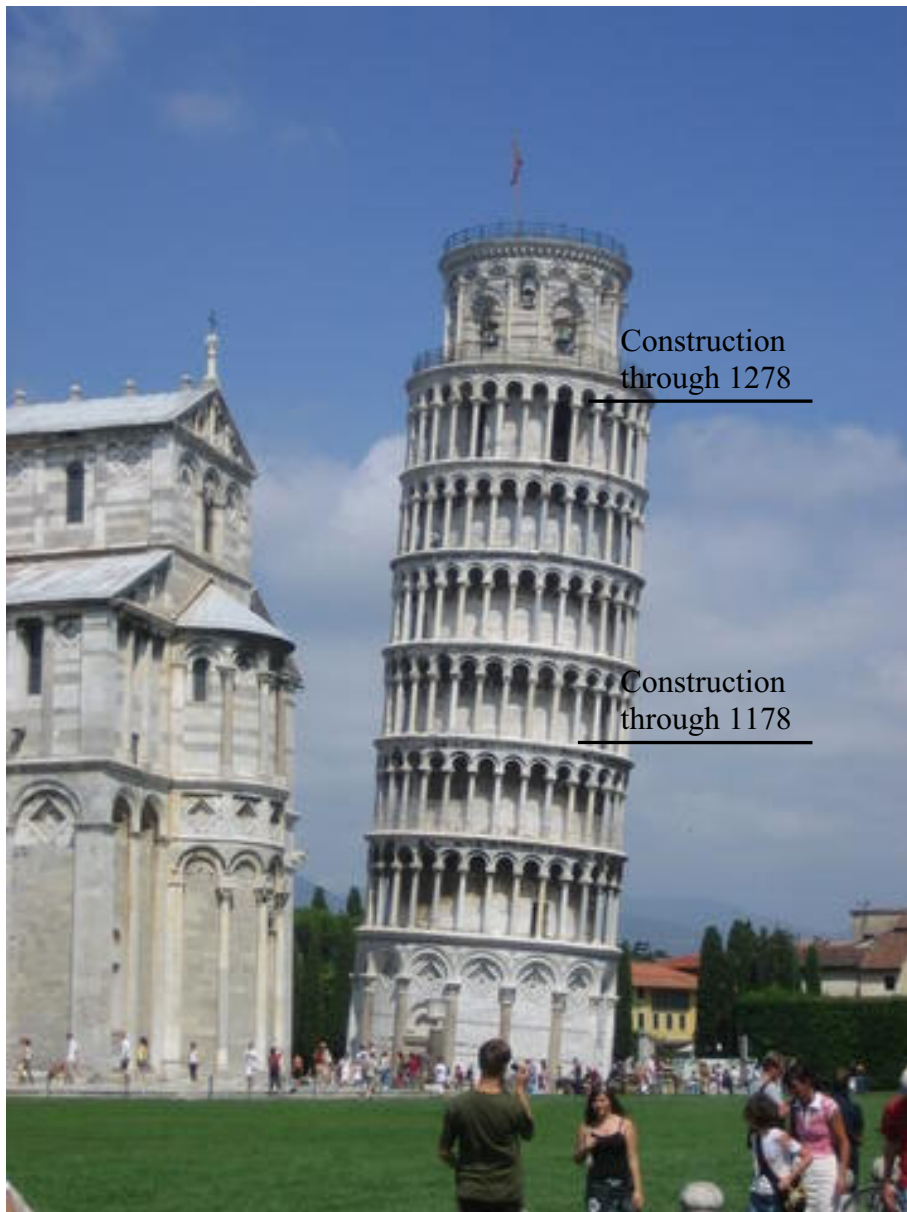
Figure 1-1. Tower of Pisa.

The Tower of Pisa (Figure 1-1) in Italy is about 60 m (200 ft) tall from foundation to belfry, 20 m (66 ft) in diameter and weighs approximately 145 MN (14,500 tons). It was constructed in three phases. Four floors were built over a 5 year period from 1173 to 1178. Following an almost 100 year hiatus, in the second phase of construction, three additional floors were constructed between 1272 and 1278. The third construction phase occurred more than 80 years later between 1360 and 1370 when the bell tower was added. The tower's foundation is inclined at almost 5.5 degrees to the south; the tower overhangs the ground about 6 m (20 ft) out of plumb. The value corresponding to the eccentricity on the loads on the foundation is 2.3 m (7.5 ft).

The failure of the Tower of Pisa is unique for a number of reasons. It is a failure that has occurred on a continuous basis for more than 800 years. Despite the extensive investigations and analyses conducted over the past 60 years, there is still no consensus on the cause of failure. What is significant however is that finally, after 8 centuries, the tower has been effectively stabilized.

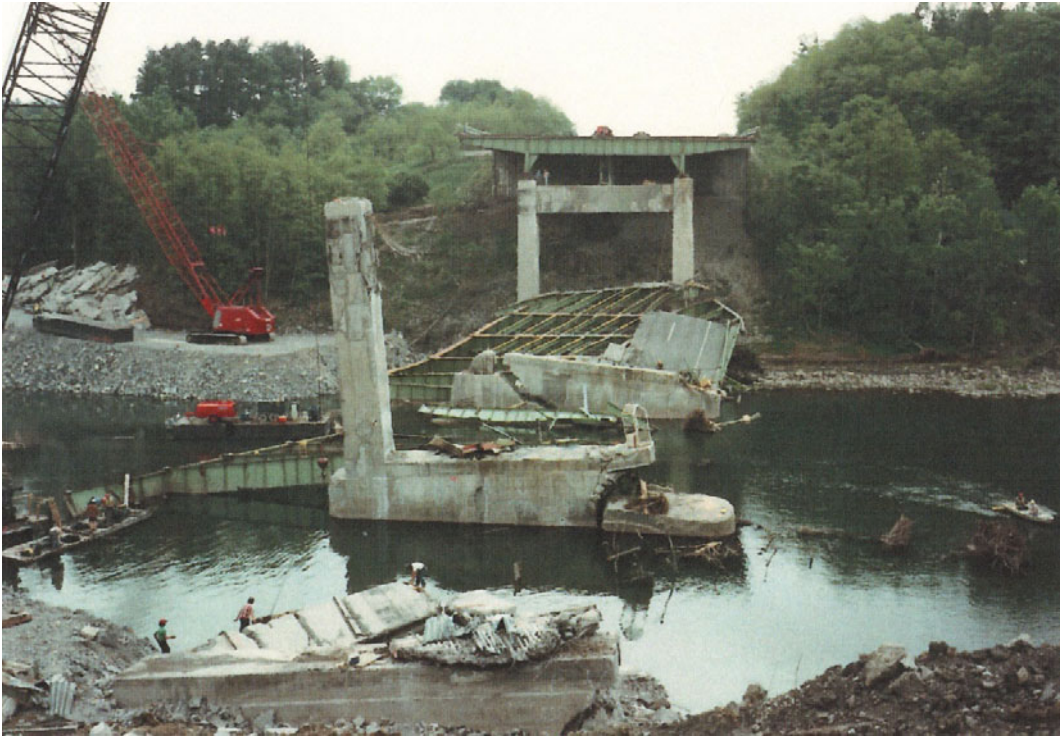
Figure 1-4. Schoharie Creek Bridge collapsed spans.

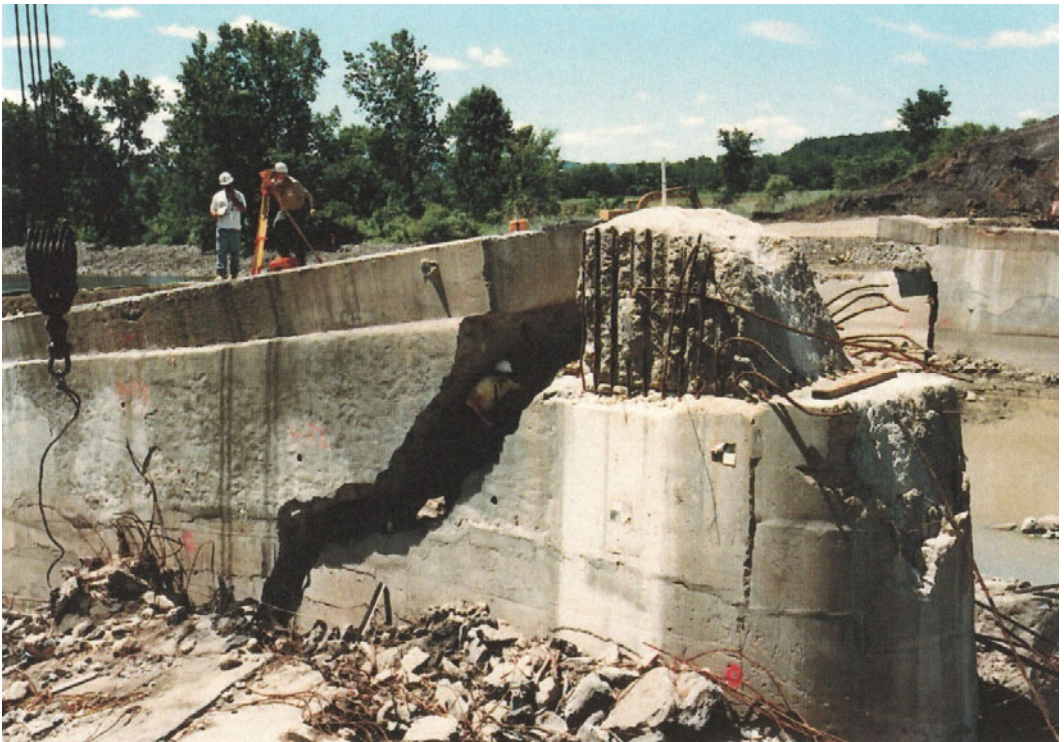
Figure 1-5. Schoharie Creek Bridge failed plinth.

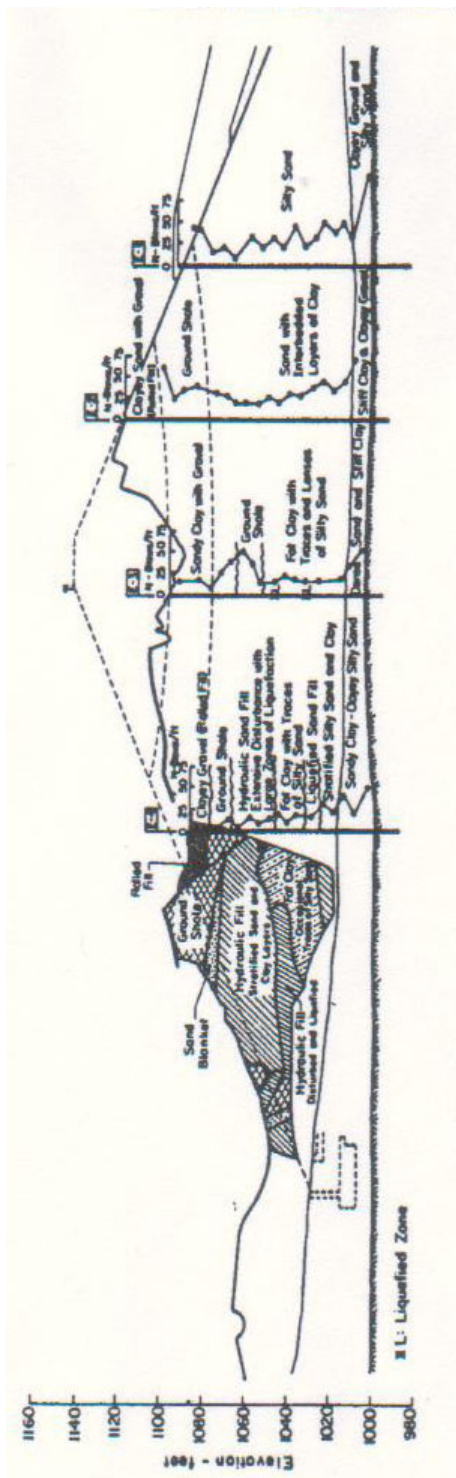
Figure 2-2. Post-Earthquake Section through Lower San Fernando Dam.
 Source: Seed, et al. (1975), ©ASCE

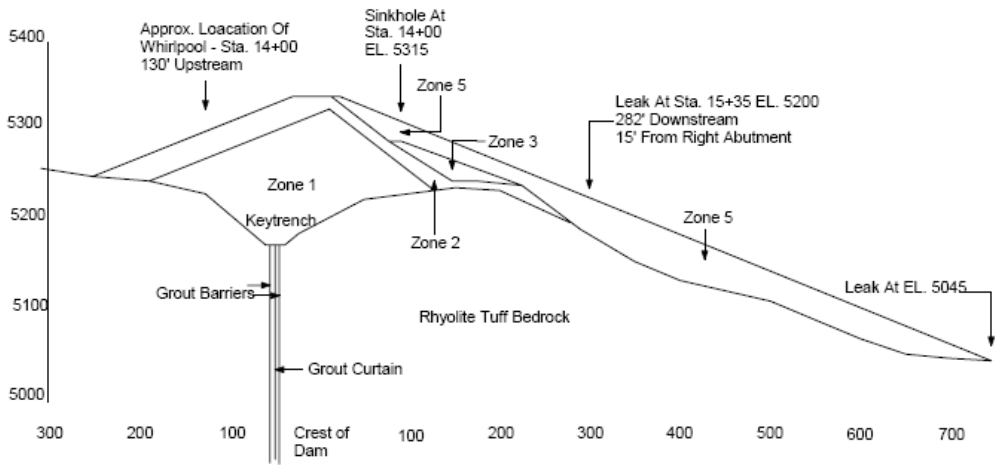
Figure 2-5. Teton Dam Initial Failure Indications.

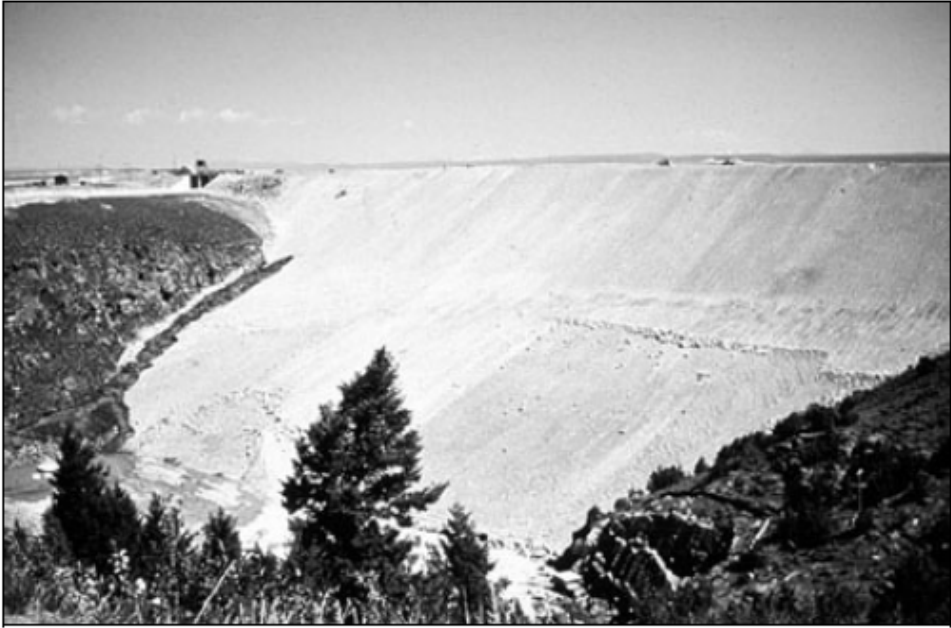
Figure 2-6. Teton Dam Failure Sequence, Initial Erosion.

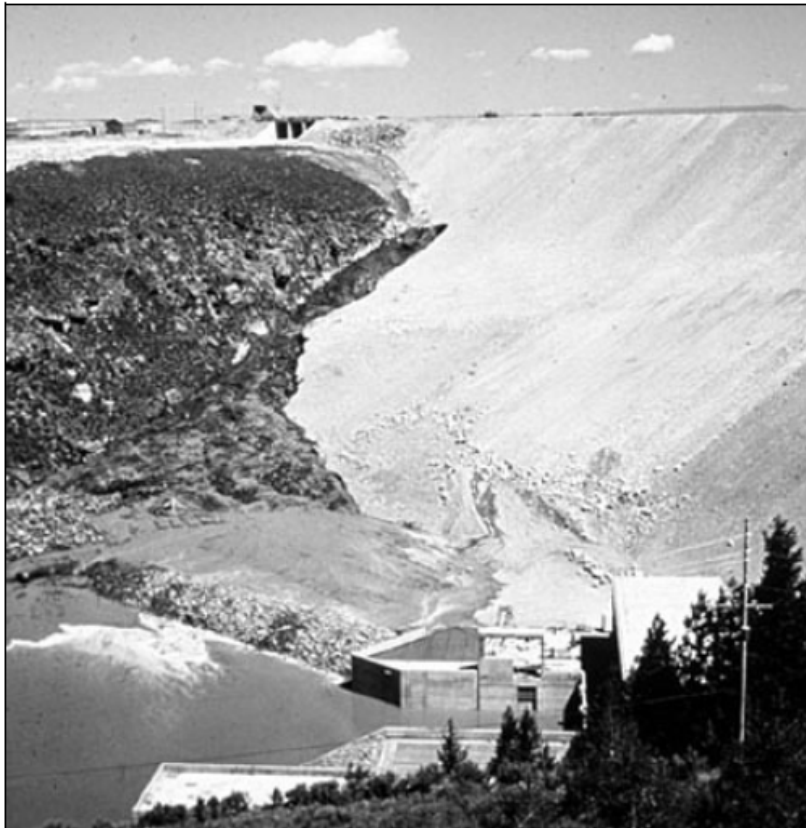
Figure 2-7. Teton Dam Failure Sequence, the Seepage Widens.

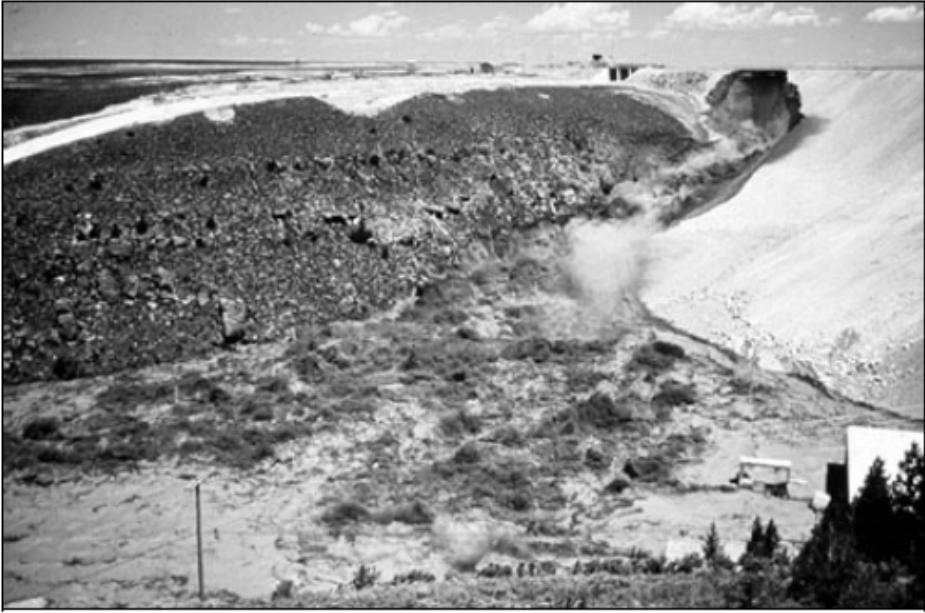
Figure 2-8. Teton Dam Failure Sequence, Beginning of Final Failure.
Source: Independent Panel (1976).

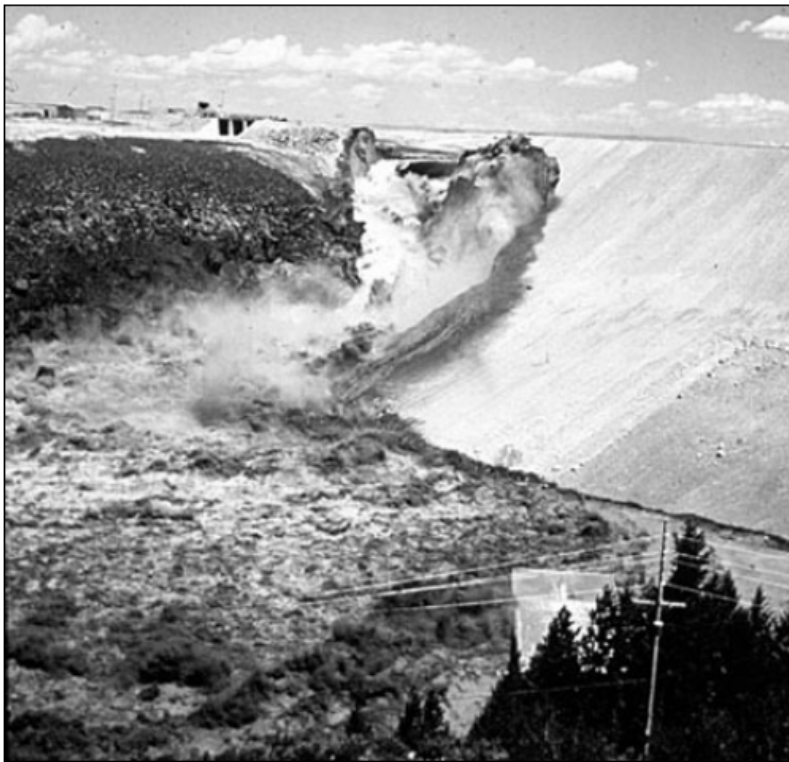
Figure 2-9. Teton Dam Failure Sequence, Failure of the Dam.
Source: Independent Panel (1976).

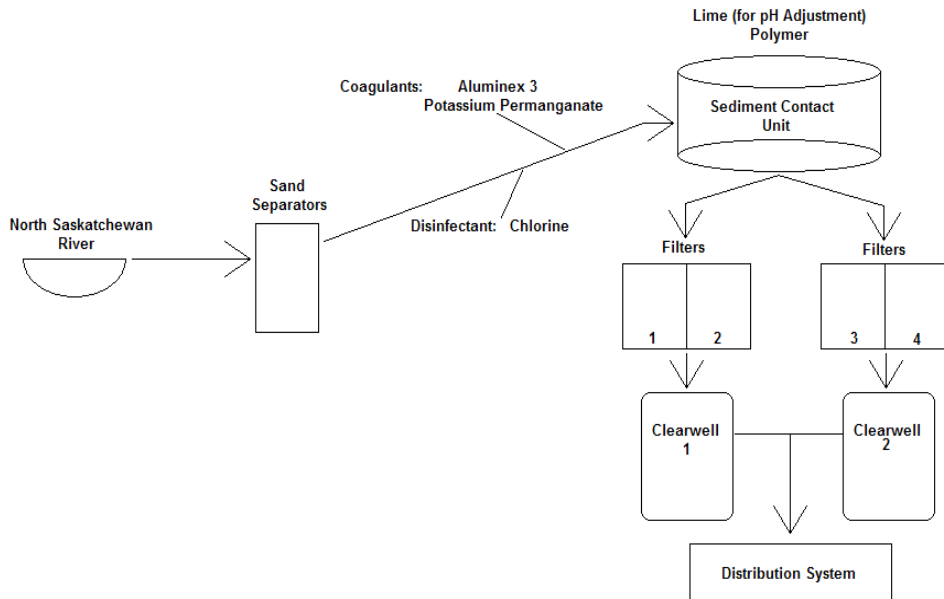
Figure 3-2. Process Diagram of North Battleford's Surface Water Plant during Cryptosporidium Outbreak.

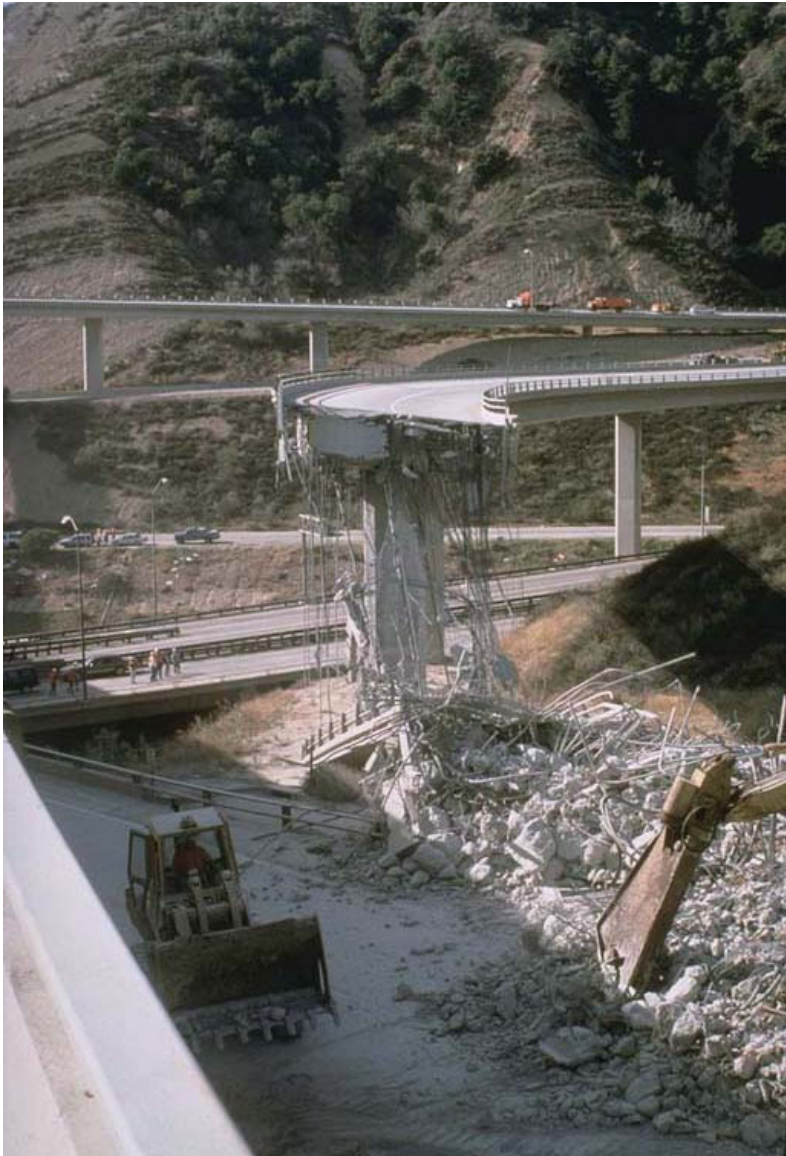
Figure 4-1. Antelope Valley – Interstate 5 Freeway Interchange Failure – 1994.
Source: J. Dewey, USGS.

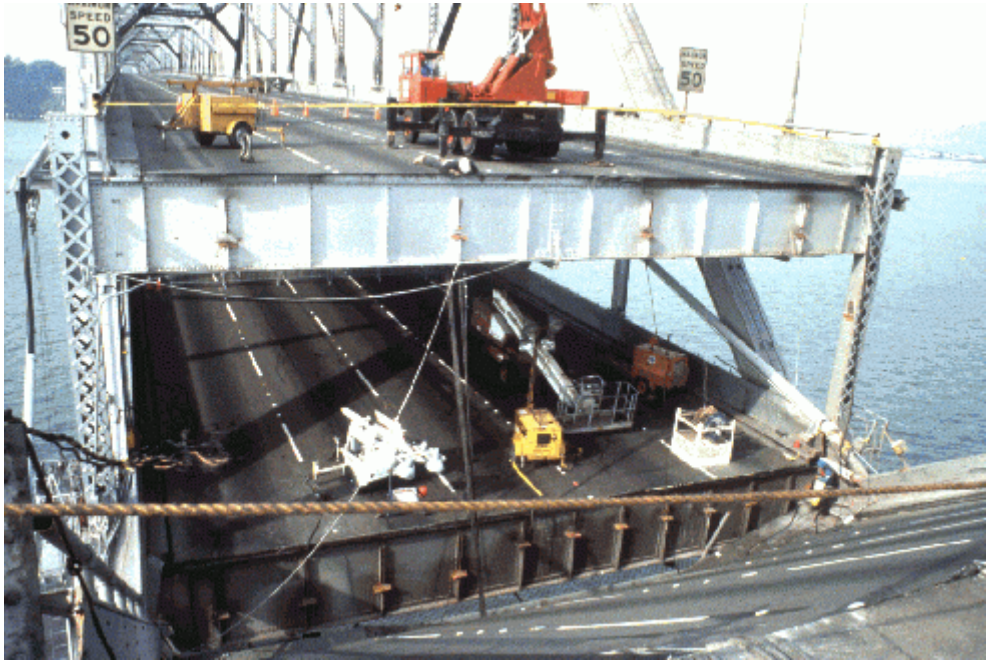
Figure 4-3. Damage to San Francisco-Oakland Bay Bridge.

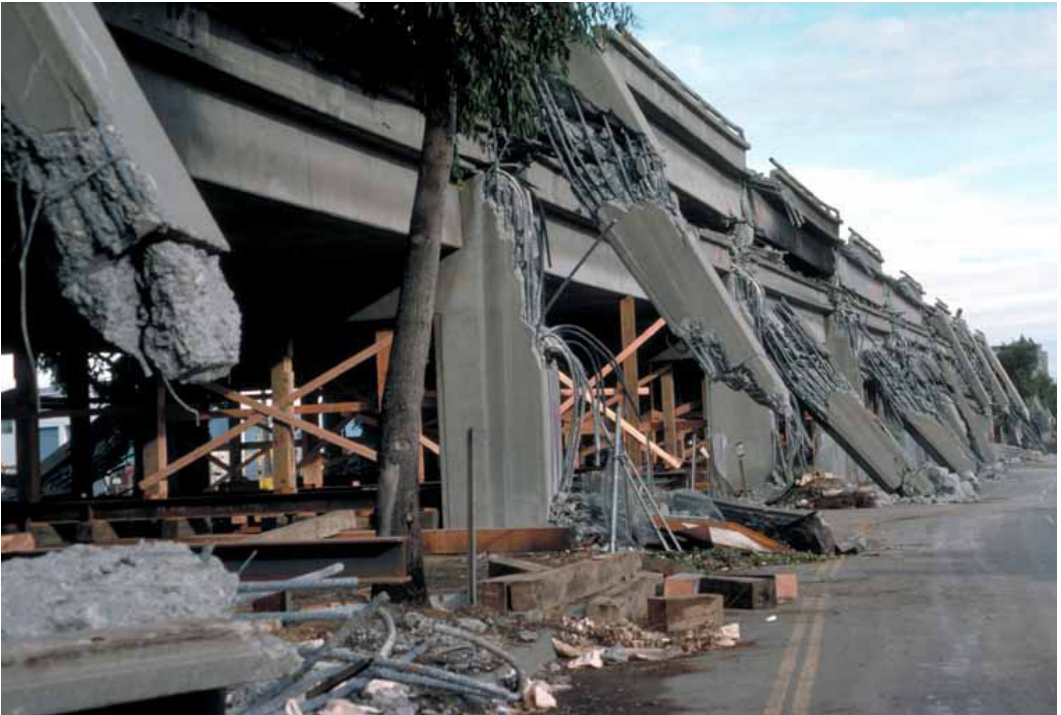
Figure 4-4. Cypress Viaduct Support Column Failure.

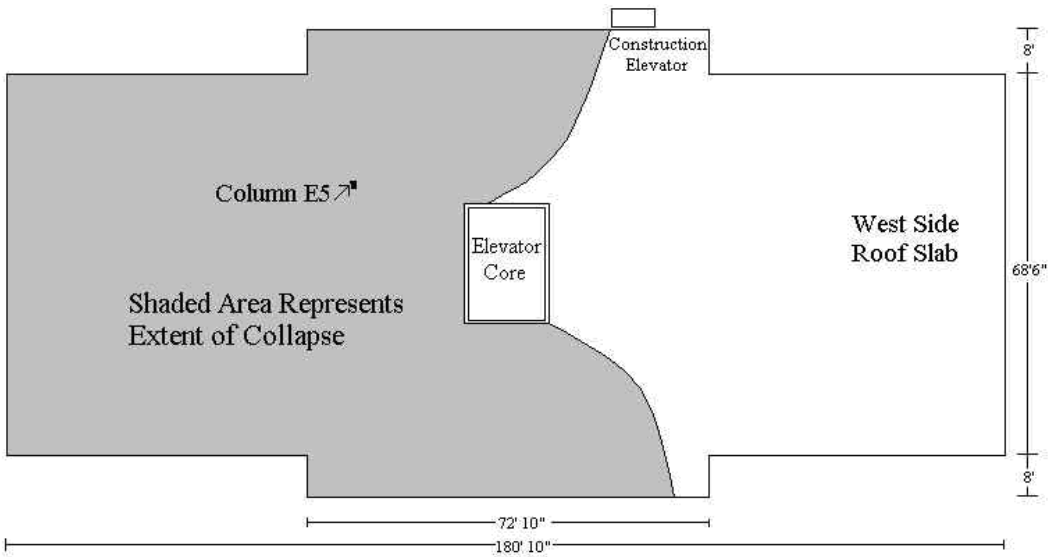
Figure 5-6. 2000 Commonwealth Avenue Building Extent of Collapse.

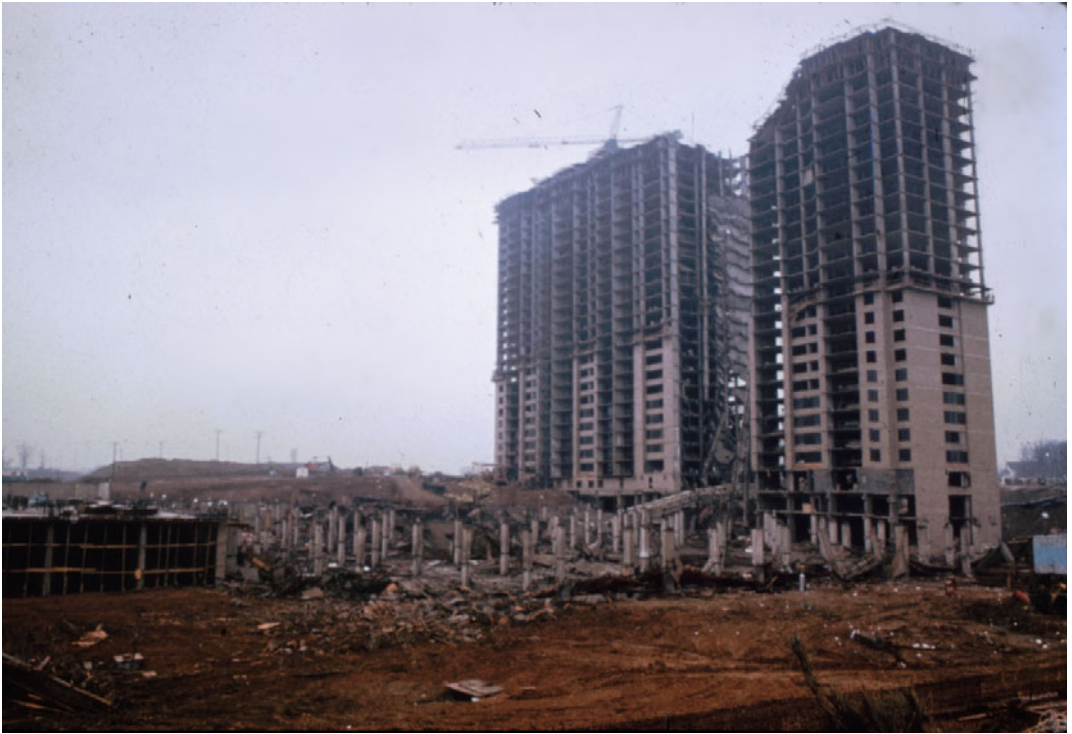
Figure 5-7. Overview of the Skyline Plaza Collapse at Bailey's Crossroads.

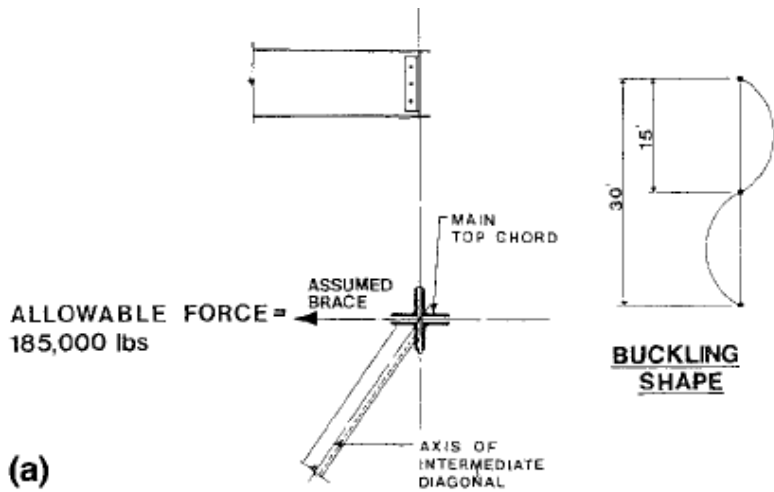
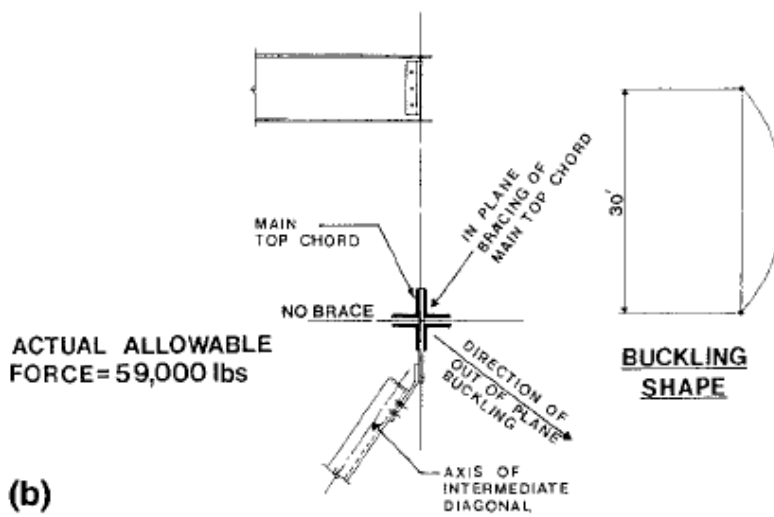
Figure 5-9. Effect of assumed (hard) versus actual (spring) bracing condition.

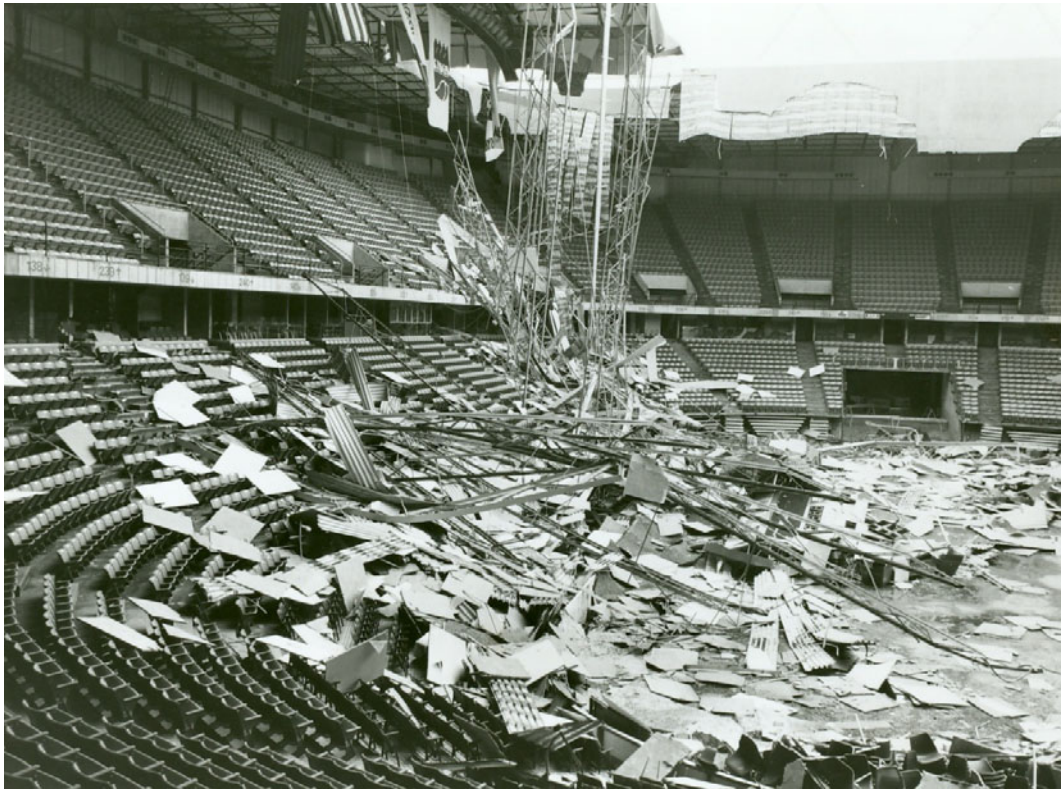
Figure 5-12. Kemper roof debris litters seats below shortly after the collapse.

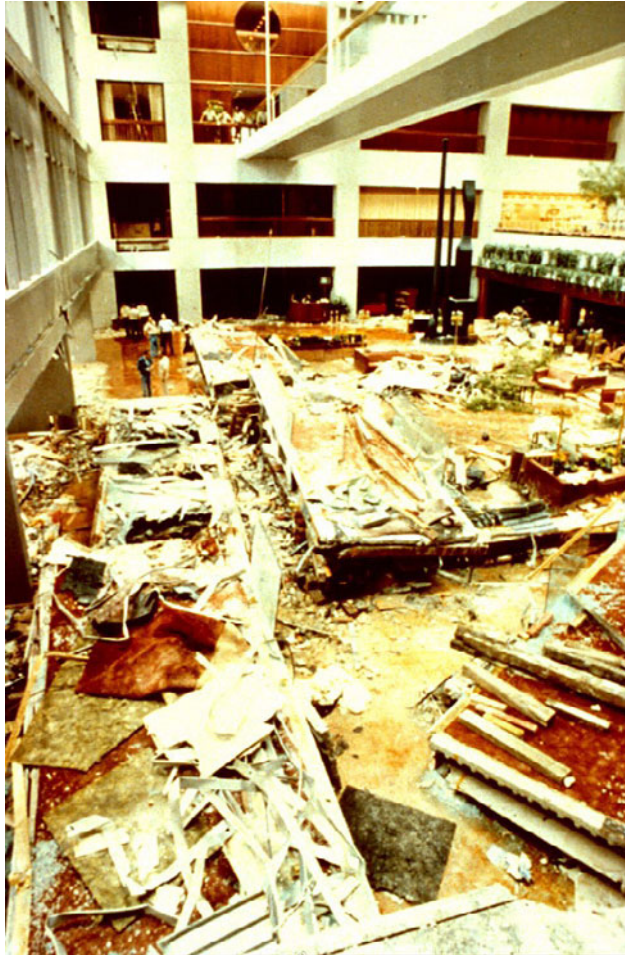
Figure 5-13. Second and Fourth Floor Skywalks collapsed in lobby.
Source: Courtesy of Wiss, Janney, Elstner Associates, Inc.

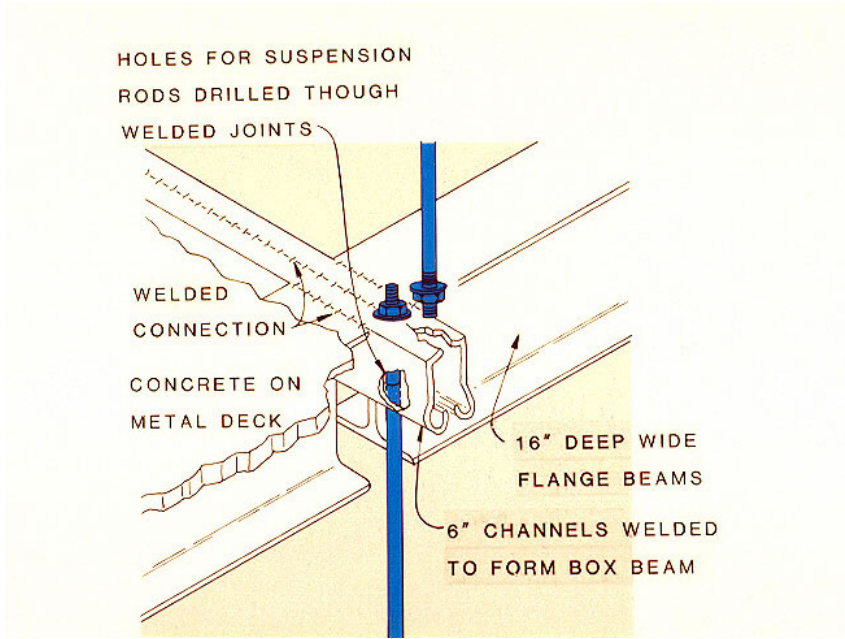
Figure 5-14. Detail of deficient connection and collapse mechanism.

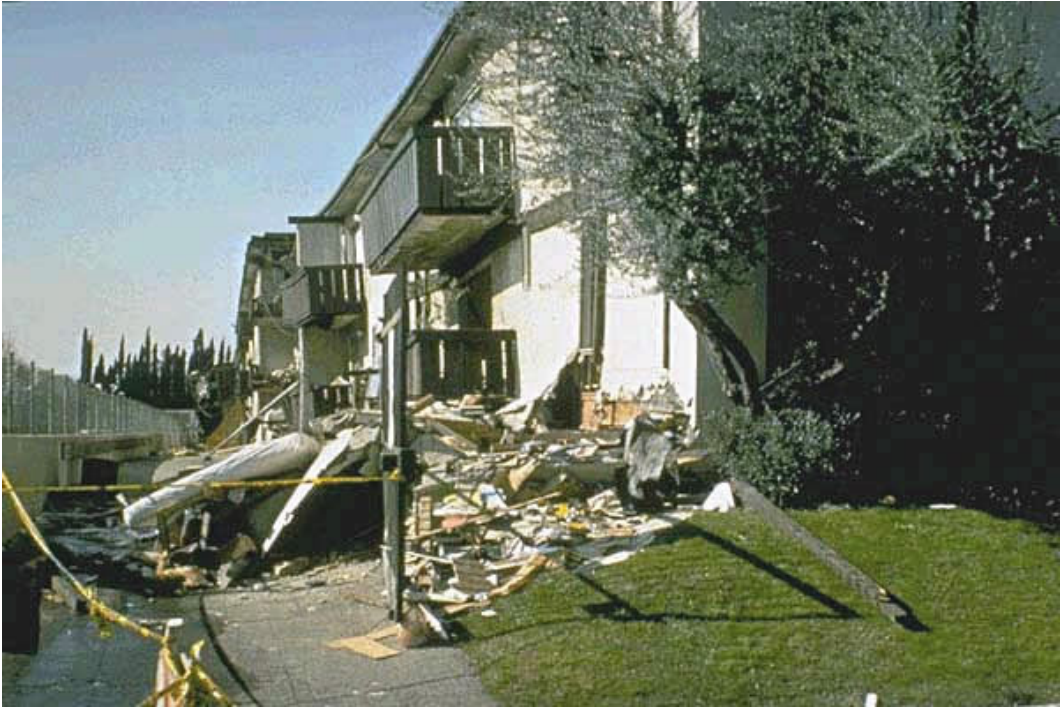
Figure 5-20. Collapsed first floor of Northridge Meadows Apartment.

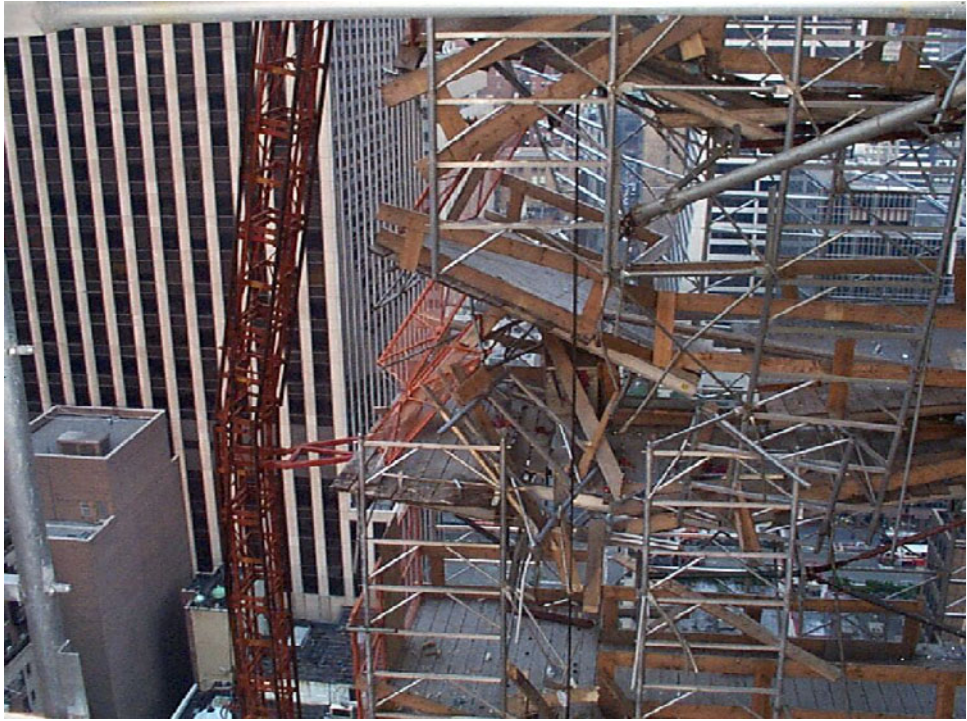
Figure 5-21. Collapse of scaffolding of Four Times Square.

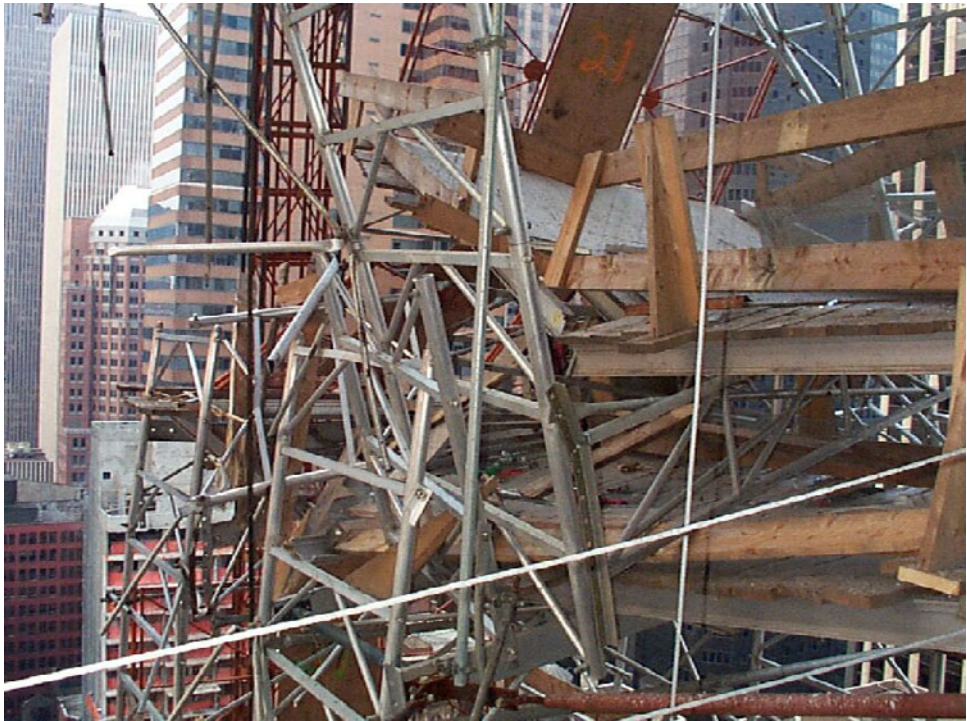
Figure 5-22. Collapse of scaffolding of Four Times Square.
